**Flood Control Project Maintenance
Levee Inspections**
LMA District Cover Sheet
Spring 2018 Levee Inspection Results

Reclamation District No. 0827 Elkhorn

Levee Inspection Report By Mile - Spring 2018

Waterway	Bank	Unit Miles	Inspection Start/End	Inspector
Unit No. 01 Sacramento River	Right	1.34	04/19/2018 04/19/2018	Zach Jojola

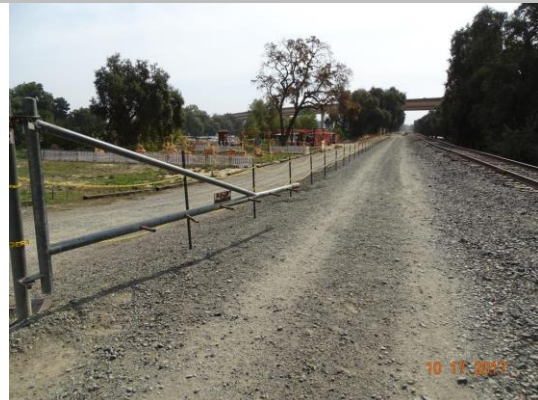
Photo 1 of 1 : SP_2018_RD0827_187_16_20180306_00009.jpg

LM Start	0.03	Rating **	M	Issue No.	16
LM End	0.15	Issue Type +	En	Location *	CR
Category	Earthen Levee			GPS Latitude/Longitude	
				Start	End
Item	Encroachments			38.674881 °	38.673668 °
				-121.630109 °	-121.628490 °
DWR ID	DWR_RD0827_01_f_2017_16				
Comment Code					
FE : Fence					
Inspector Comment					
Fence installed by adjacent tourism company.

View of fence on crown. Fall 2017.

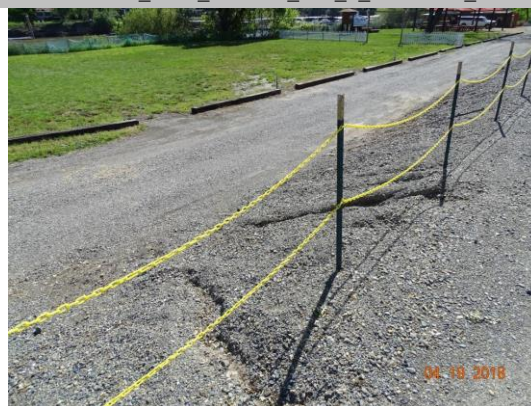
Photo 1 of 1 : SP_2018_RD0827_187_6_20180423_00016.jpg

LM Start	0.04	Rating **	A/W	Issue No.	6
LM End	0.04	Issue Type +	Ma	Location *	WS
Category	Earthen Levee			GPS Latitude/Longitude	
				Start	End
Item	Erosion / Bank Caving			38.674833 °	38.674833 °
				-121.630039 °	-121.630039 °
DWR ID	DWR_RD0827_01_s_2018_6				
Comment Code					
E1 : Note and monitor erosion site.					
Inspector Comment					
Small rills beginning to form on waterside slope. Recommend monitoring.

View of rills on the waterside slope. Spring 2018.

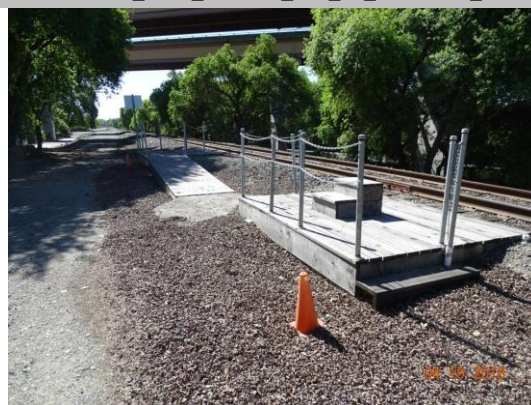
Photo 1 of 2 : SP_2018_RD0827_187_10_20180423_00015.jpg

LM Start	0.14	Rating **	M	Issue No.	10
LM End	0.14	Issue Type +	En	Location *	CR
Category	Earthen Levee			GPS Latitude/Longitude	
				Start	End
Item	Encroachments			38.673767 °	38.673767 °
				-121.628593 °	-121.628593 °
DWR ID	DWR_RD0827_01_s_2016_10				
Comment Code					
ST : Stairway					
Inspector Comment					
Railroad has put steps on the crown for the tourist train from the West City of Sac water plant. Stairs are not permitted and was placed Spring 2016. The railroad has added a wheelchair access ramp.

View of the existing stairs and new ramp. Spring 2018.

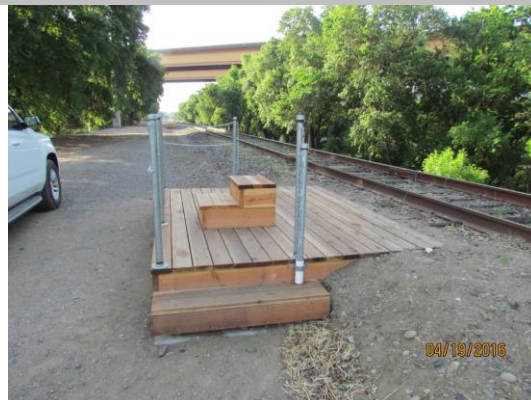
Photo 2 of 2 : SP_2018_RD0827_187_10_20180306_00004.jpg

View of the stairs on the crown of the levee looking downstream. Spring 2016.

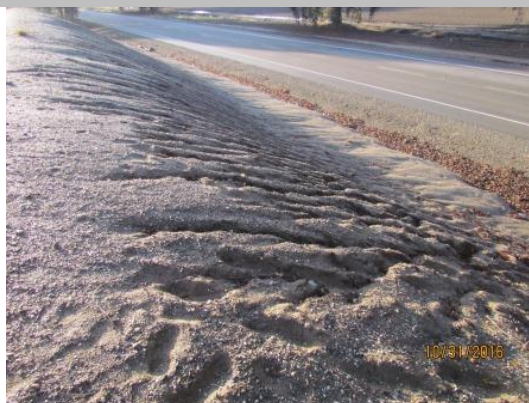
Photo 2 of 2 : SP_2018_RD0827_187_13_20180306_00007.jpg

Updated view of runoff erosion site. LS slope. Fall 2016.

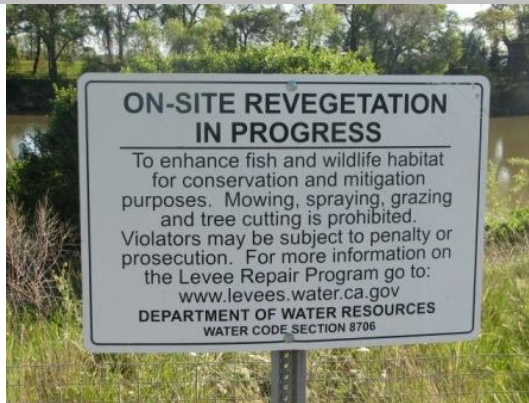
Photo 1 of 2 : SP_2018_RD0827_187_22_20180306_00010.jpg

LM Start	0.61	Rating **	A/W	Issue No.	22
LM End	0.92	Issue Type +	Ma	Location *	WS
Category	Earthen Levee			GPS Latitude/Longitude	
				Start	End
Item	Vegetation			38.668873 °	38.665750 °
				-121.622513 °	-121.618523 °
DWR ID	DWR_RD0827_01_s_2012_22				
Comment Code					
V8 : Environmental Requirements.					
Inspector Comment

Revegetation site spring 2012.

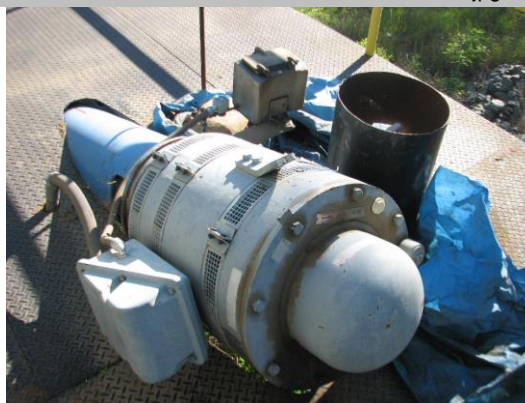
Photo 3 of 3 : UCIP_SP_2018_38983_59735.jpg

Slant pump located on waterward side.

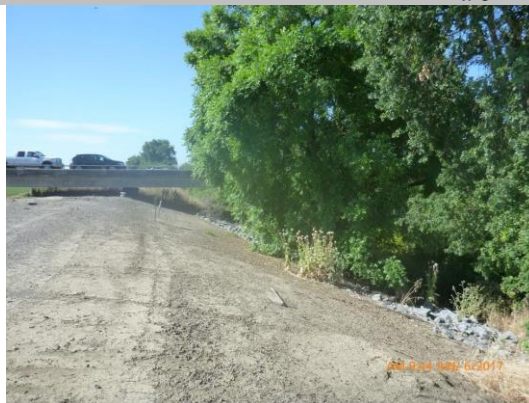
LM Start	0.15	Rating **	A/W	Issue No.	10
LM End	0.16	Issue Type +	Ma	Location *	
Category	Supplemental			GPS Latitude/Longitude	
				Start	End
Item	2017 Storm Damage			38.674778 °	38.674583 °
				-121.642806 °	-121.642722 °
DWR ID	DWR_RD0827_02_f_2017_10				
Comment Code					
Inspector Comment					
Levee Evaluation Comments					
Description:					
Site ID No:200					
Site Designation:RD 827-02					
Repair Type: Erosion					
Rating:Area of Concern					
Field Date:6/6/2017					
Notes: no damage visible, ws armored with riprap

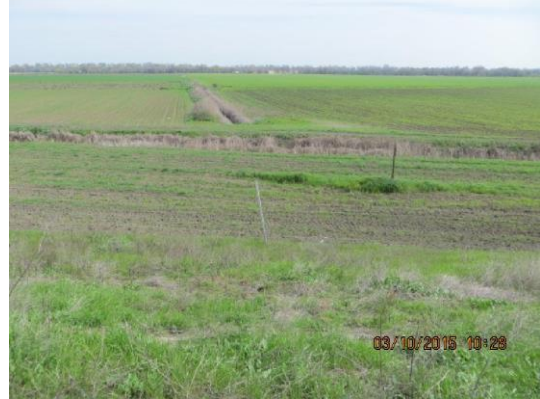
Photo 1 of 3 : UCIP_SP_2018_50030_73360.jpg

Comment Code						
Inspector Comment						
FS_ID:50030 DS_ID:21159 EP_NO: 15904 Repair Type: Urgent Crossing Status: Indicator Found UCIP Comments: 8/31/2016 Meet with Greg Lucas, Assistant Production Coordinator from California Resources Corporation and Steve Steim from Noble Methan, Inc. to discuss the status of a different line upstream. Mr. Steve Steim was aware of the 3-inch line by Two Bay Petroleum as known as a PG&E old pipe at this location. According to Steve Stein the appurtenances previously located on the landside have been removed and the 3-inch line abandoned. Need to contact owner to confirm status of crossing. If crossing is no longer in use the owner will need to coordinate with CVFPB to comply with Title 23. (DWR UCIP - omagana)8/04/2016 No markers found on either WS or LS. Need to coordinate with owner to determine status of crossing. (DWR UCIP - omagana)3/10/2015 Sign missing on WS and LS. Need to confirm status of crossing with permittee. Appears abandoned. (DWR UCIP - wwylie) 03/18/2014 crossing not found. (DWR UCIP - omagana) FIELD_STRUCT_DESC: 3-inch steel gas pipeline through the levee, 20 feet below the crown. Sign on waterside (WS) (not found 2015). Yellow pipe visible east of ditch approximately 150 feet off landside (LS) toe. Contact Number 415-459-3445 for Two Bay Petroleum also referred as Pacific Energetics, Inc. (3-inch line authorized under Permit No. 15904, 1992 - Two Bay Petroleum) FS Date: 8/4/2016

View of LS.

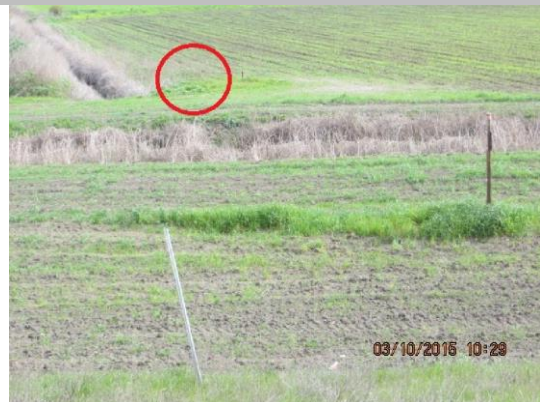
Photo 2 of 3 : UCIP_SP_2018_50030_73361.jpg

Pipe visible east of ditch approximately 150 ft off LS toe.

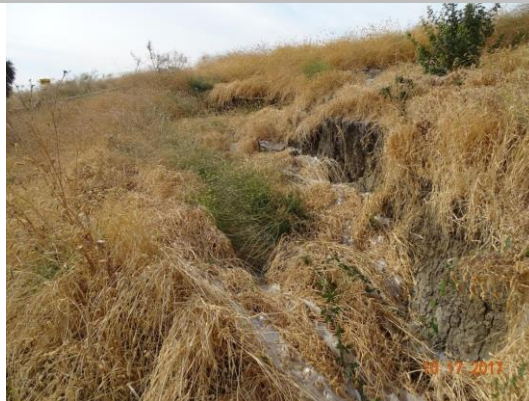
Photo 1 of 4 : SP_2018_RD0827_188_13_20180306_00009.jpg

LM Start	2.72	Rating **	M	Issue No.	13
LM End	2.73	Issue Type +	Ma	Location *	
Category	Supplemental			GPS Latitude/Longitude	
				Start	End
Item	2017 Storm Damage			38.642139 °	38.642028 °
				-121.620750 °	-121.620667 °
DWR ID	DWR_RD0827_02_f_2017_13				
Comment Code					
Inspector Comment					
Levee Evaluation Comments					
Description:					
Site ID No:199					
Site Designation:RD 827-01					
Repair Type: Erosion					
Rating:Area of Concern					
Field Date:6/6/2017					
Notes: landside. Visqueen has dried up and is no longer protecting the slope.

Updated view of sloughing on landside slope. Fall 2017.

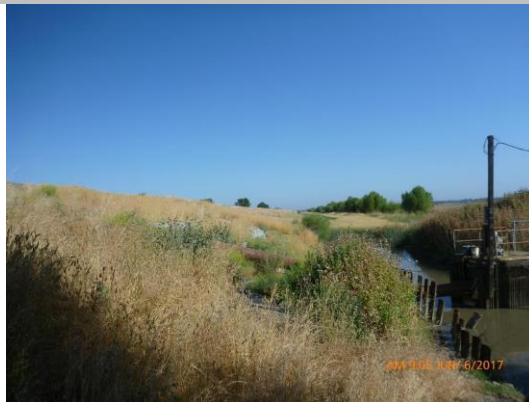
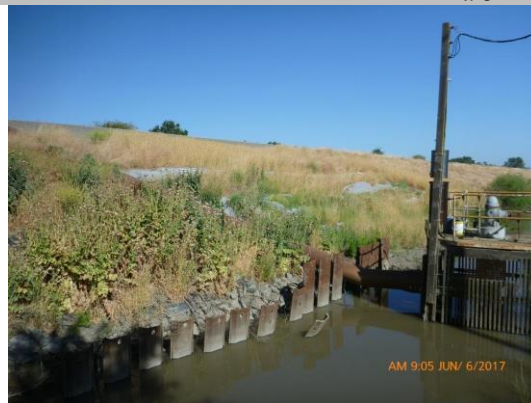
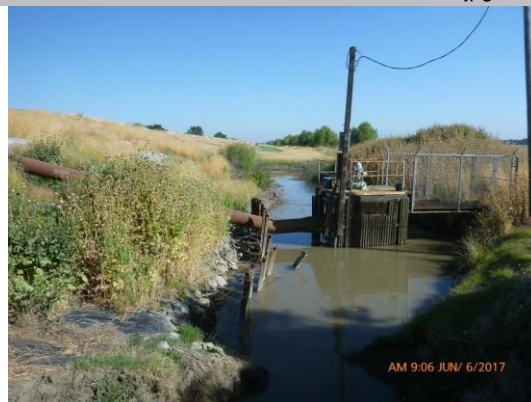
LM Start	2.72	Rating **	M	Issue No.	13 (cont)
LM End	2.73	Issue Type +	Ma	Location *	
Category	Supplemental			GPS Latitude/Longitude	
				Start	End
Item	2017 Storm Damage			38.642139 °	38.642028 °
				-121.620750 °	-121.620667 °
DWR ID	DWR_RD0827_02_f _ 2017_13				
Comment Code					
Inspector Comment					
Levee Evaluation Comments					
Description:					
Site ID No:199					
Site Designation:RD 827-01					
Repair Type: Erosion					
Rating:Area of Concern					
Field Date:6/6/2017					
Notes: landside. Visqueen has dried up and is no longer protecting the slope.

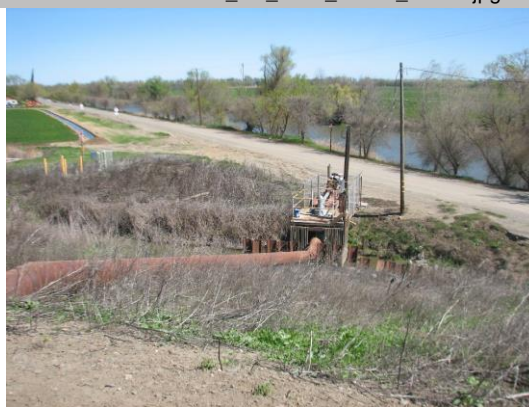
Photo 2 of 3 : UCIP_SP_2018_38984_59768.jpg

View of landward side.
